Client: Kay Nash
Subject: Structural Insp., 13 Orchard Way, N. Potomac MD
Encl: Photographs

Scope of Inspection/Background

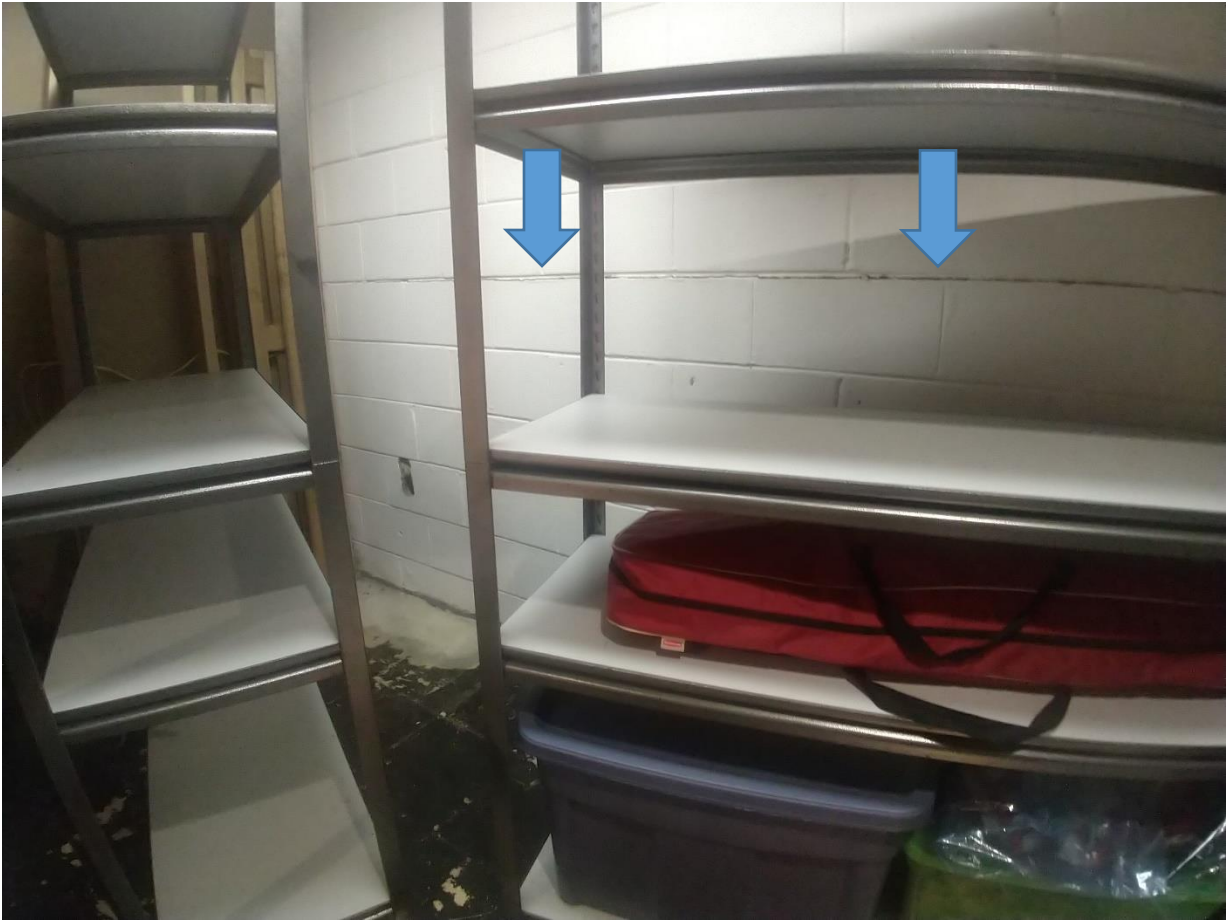
Photo 1

The house foundation is concrete block (CMU). There is a horizontal crack at rear of the basement in the unfinished area (photo 1). The maximum crack width is about 1/4" and there is inward deflection of the wall up to about 1" at the midpoint of the unfinished area. The inward movement diminishes as you move away from the midpoint of the exposed foundation wall.

No foundation repairs are needed. The cracks can be safely monitored; should conditions change further investigation is needed. Managing exterior grading/drainage is important to minimizing risks of future movement.
